# Five-Year Review Report

Fourth Five-Year Review Report  
For  
The Western Sand and Gravel Superfund Site  
Burrillville and North Smithfield  
Providence County, Rhode Island 02895

September 2008

Prepared by:  
The United States Environmental Protection Agency  
Region 1, New England  
Boston, Massachusetts

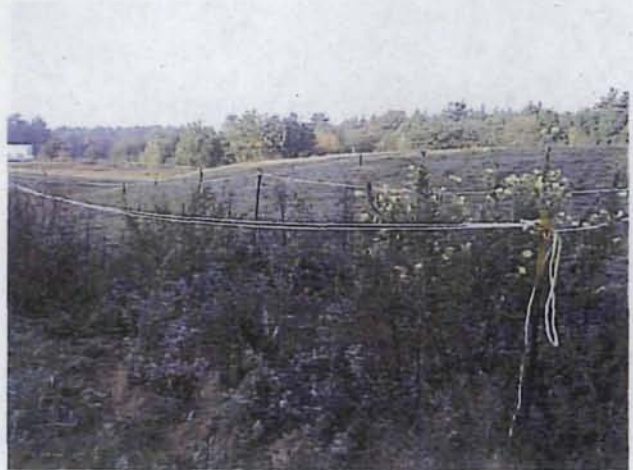
Photo 12: View of subsidence repair area.

No settling or subsidence (adequate drainage)	No erosion damage (or frost heave damage)	Good vegetation	Comments*
Cap area	X	X	NO*	August 2006 repairs are adequate
West bank area	X	X	X	
Area south of south drainage swale	X	X	X	
Other areas	X	X	X

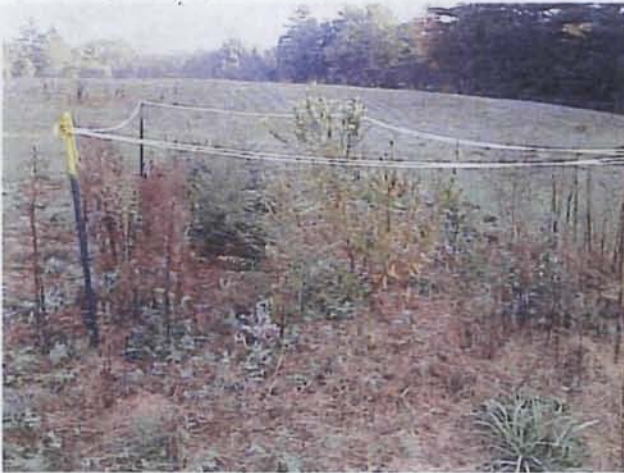
Photo 13: View of subsidence repair area.

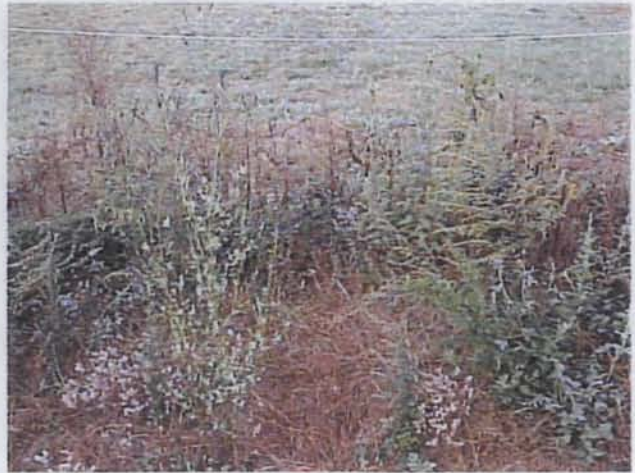
Photo 14: View of subsidence repair area.

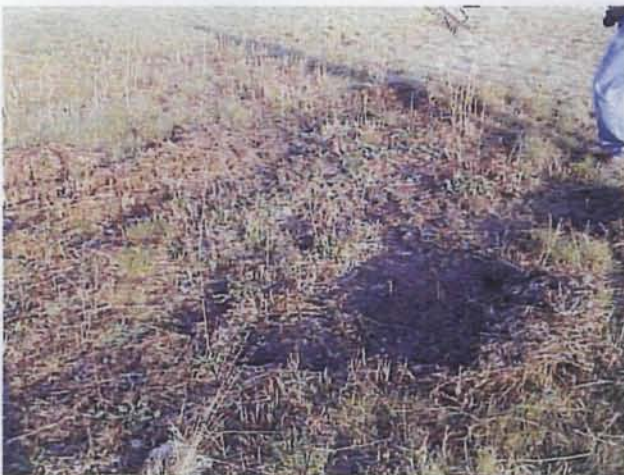
Photo 15: View of typical area of limited vegetative cover growth observed on the cap.

Site inspections were conducted by the PRPs contractor during each of the groundwater sampling events conducted during 2003 (March, and September), 2004 (March, and September), 2005 (March, and September), 2006 (March, and September), and 2007 (April and October). Overall, there were no conditions identified that would compromise the remedy. The general maintenance activities included: replacement of rusted locks, maintenance of vegetation along fence lines; removal of young trees sprouting along the eastern side of the fence, re-insertion of the rail ends along the eastern side of the fence, and the re-seeding and mulching of sub-areas

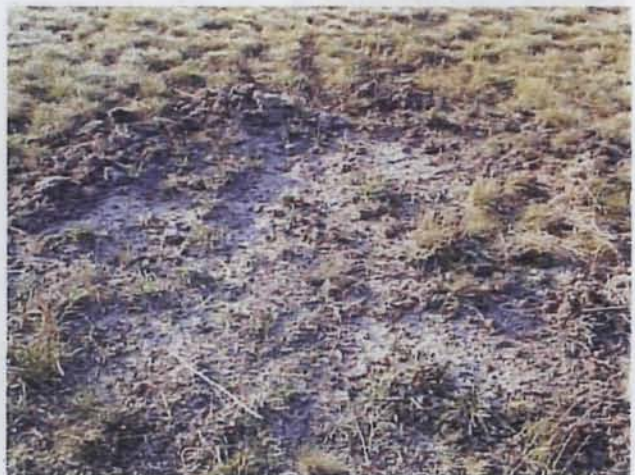
Photo 16: View of typical area of limited vegetative cover growth observed on the cap after seeding and mulching.

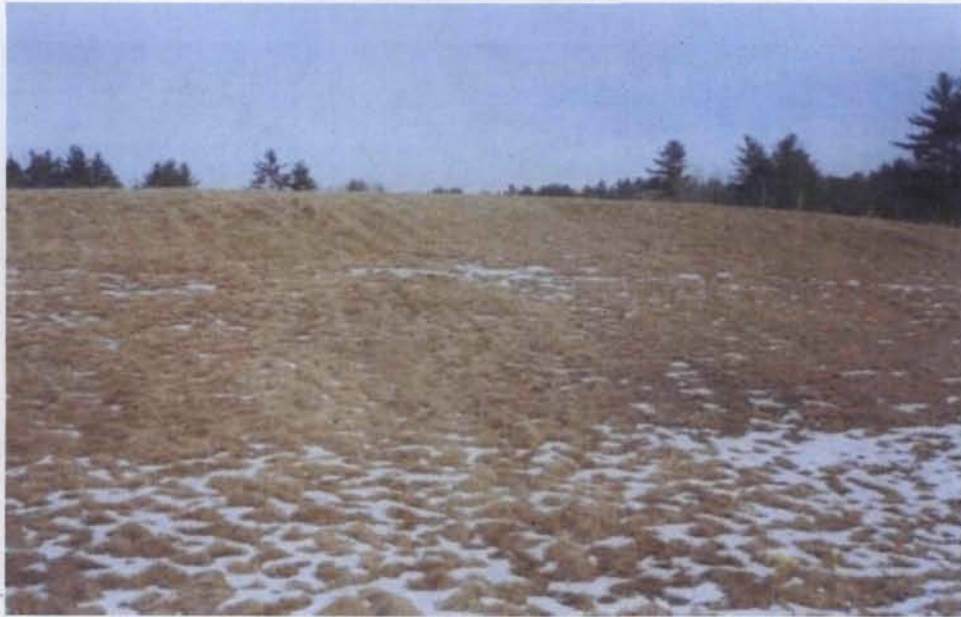
Photo 3: View of the cap facing north

On March 28, 2008 EPA performed its Site Inspection. The cap was observed to be well maintained. There were no observed low spots or ponded waters, no erosion damage, and no observed animal burrows in the cap. Appendix G is a photographic summary of general Site conditions as observed during the most recent Site inspection.
